Stormwater Division

MEMORANDUM

Wellspring United Methodist Church

Re: Wellspring United Methodist Church Expansion
County Plan No. SP-154-00
County BMP ID Code: PC ~~154~~ 172

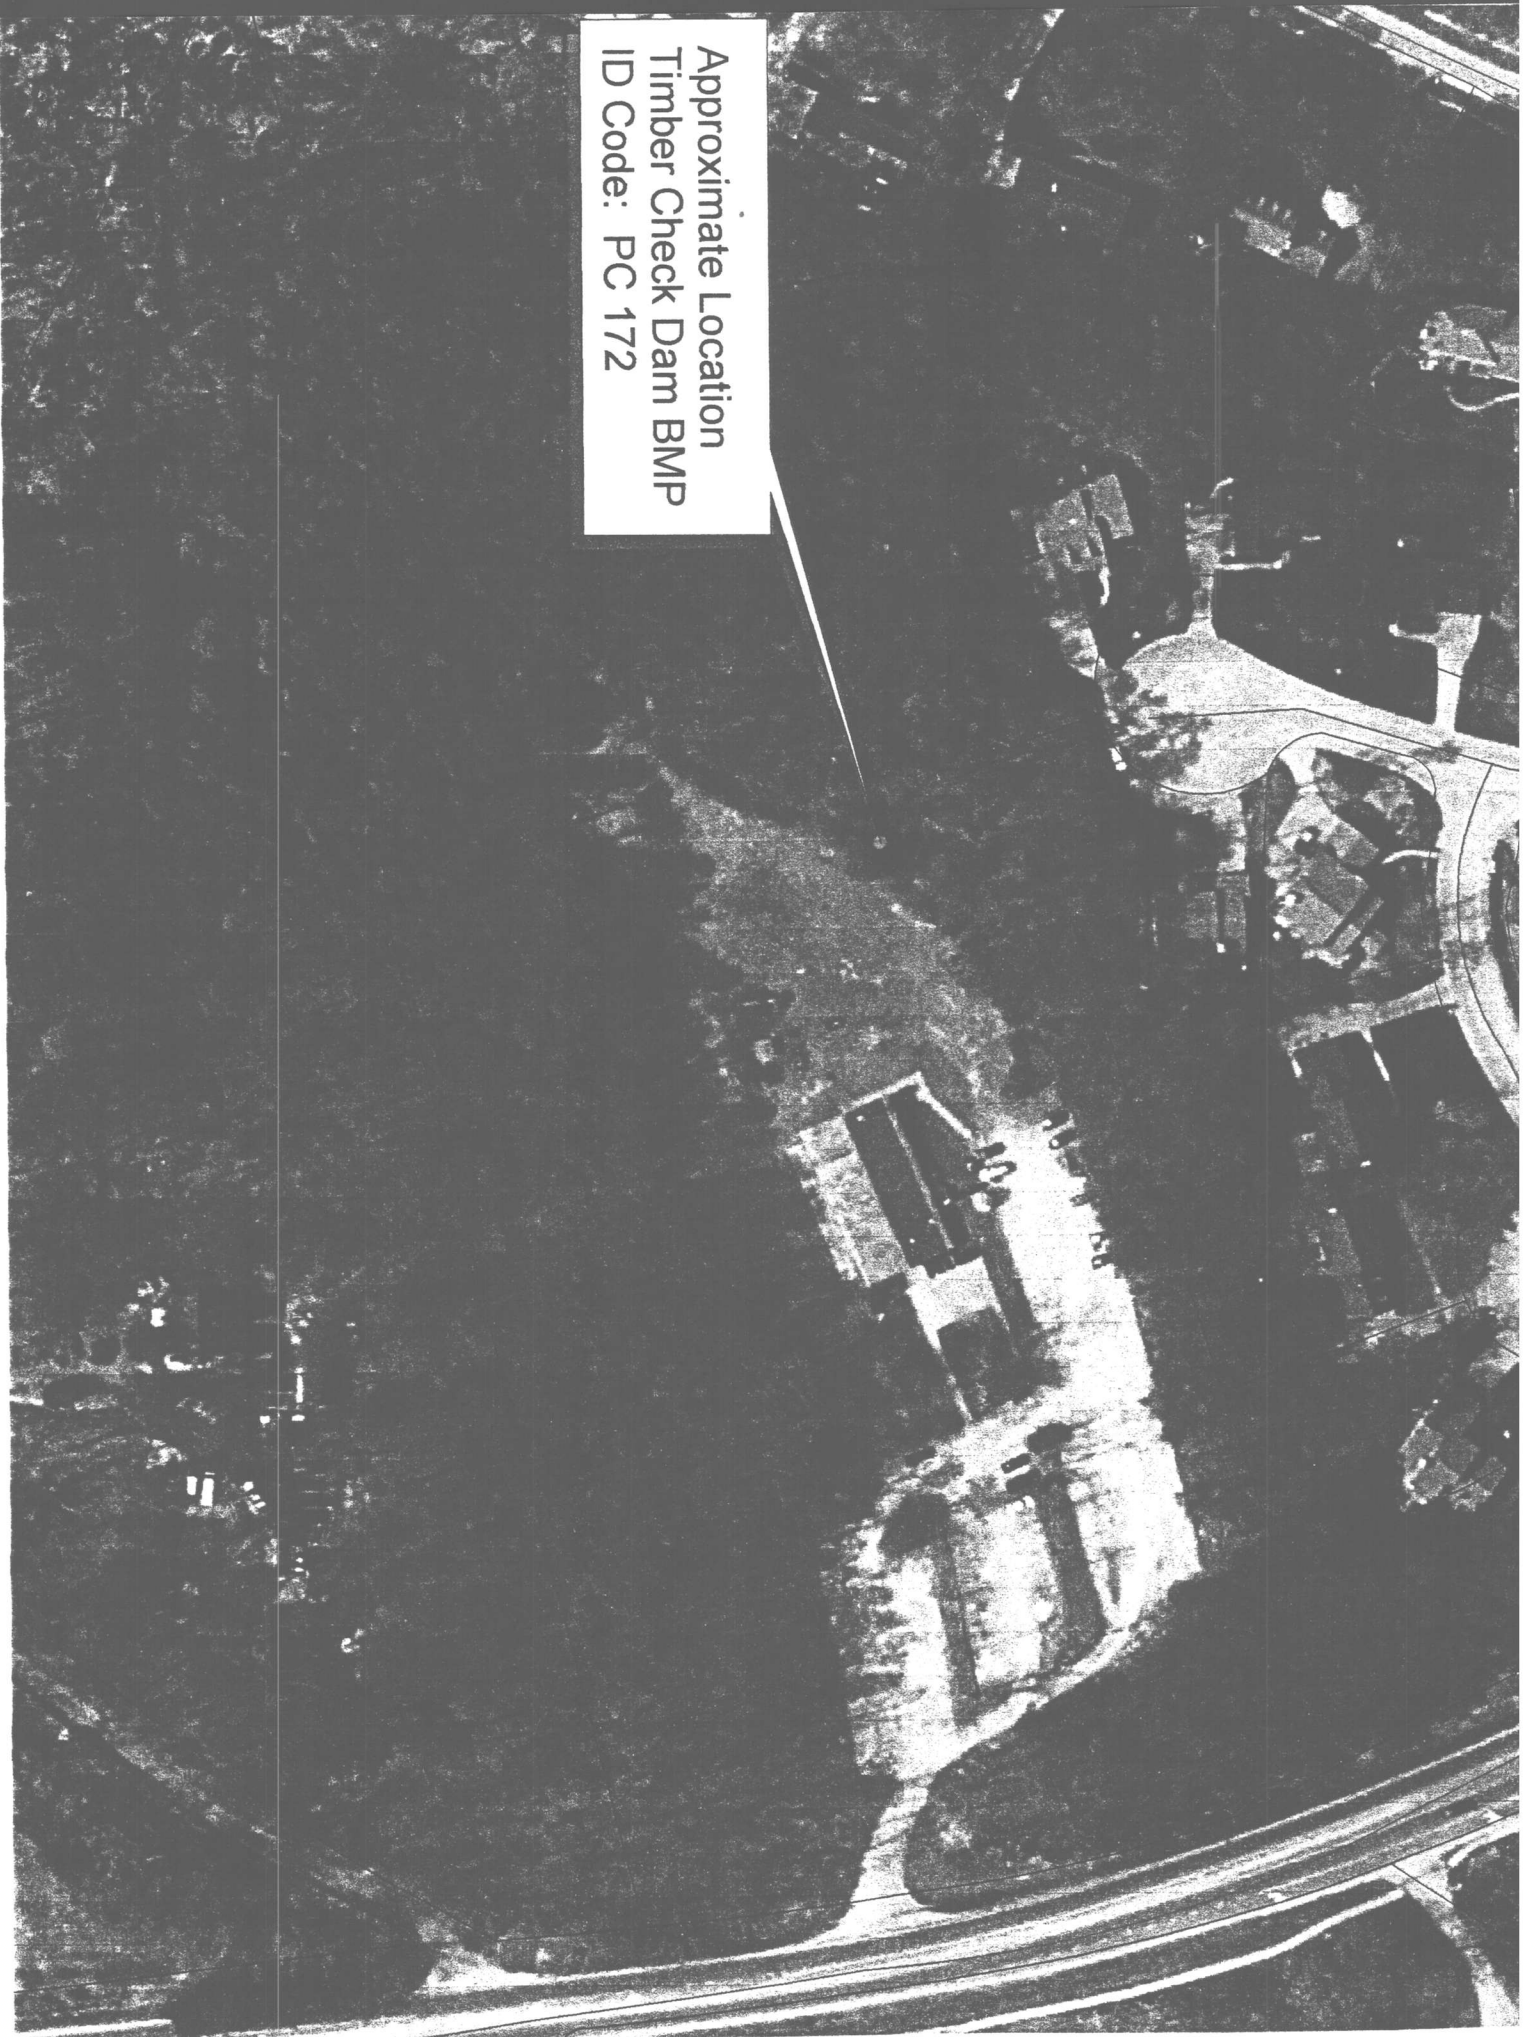
Approximate Location
Timber Check Dam BMP
ID Code: PC 172

- The project was a small redevelopment type project.
- The stormwater BMP for the site is a simple check dam structure situated in the natural channel to the northwest of the main building. The timber check dam is of simple design and construction. It consists of consists of double stacked, low profile 6-inch x 6-inch treated timbers with dumped stone on the upstream side. (Note: A map showing the approximate location of the BMP is attached).

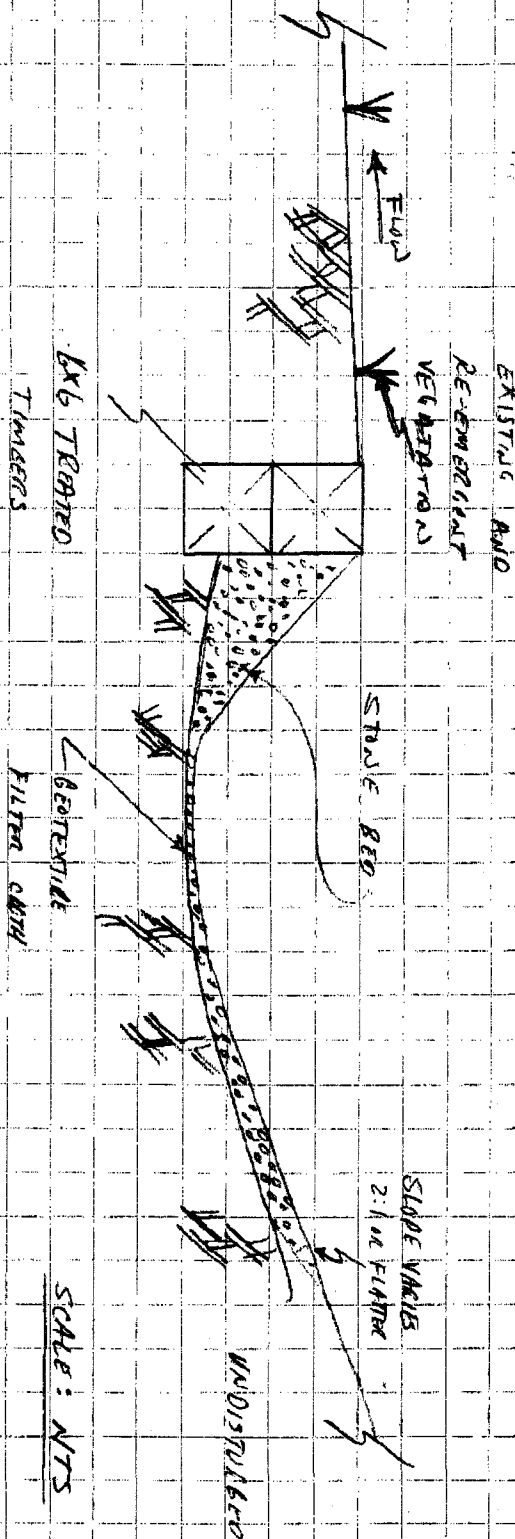
CHECK DAM AS BUILT

I hereby certify to the best of my knowledge and belief that this record drawing represents the actual condition of the Stormwater Management / BMP facility. The facility appears to conform with the provisions of the approved design plan, specifications and stormwater management plan, except as specifically noted. (SEE AMENDED DRAWING)
